May 22, 2016 Howard and Glasscock County Tornadoes

On May 23, 2016, meteorologists from the National Weather Service in Midland conducted a damage survey over portions of Howard and Glasscock counties for damage caused by severe thunderstorms during the evening hours on Sunday, May 22.

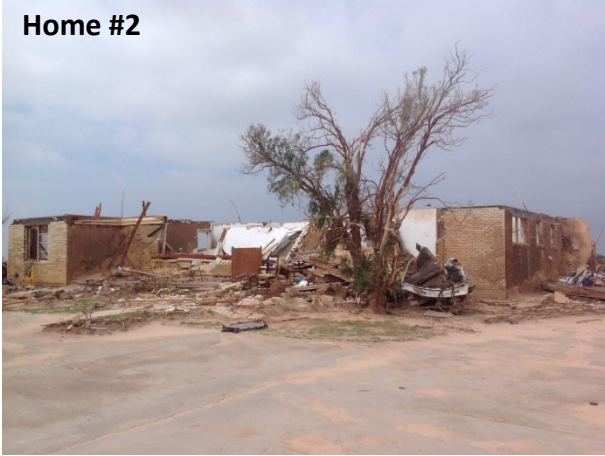
South of Interstate 20, the tornado exhibited erratic movement, being described by chasers and spotters as being “nearly stationary in a field.” Examination of radar imagery showed the primary storm circulation moved slowly southeastward to approximately $\frac{1}{2}$ mile northwest of the intersection of Lintner Road and Rockhouse Road by 6:37 pm CDT, before turning eastward. The tornado continued to move east, with the southern periphery of the tornado affecting Home #1 (indicated on map). The tornado then began to move northeastward, crossing nearly directly over Home #2 around 6:40 pm CDT. A slight

tornado during the most intense portion of the tornado's life cycle, the entire roof was destroyed and exterior walls on this well-constructed residence were partially collapsed. This damage indicator suggests an EF3 intensity with wind speeds estimated at 140-160 mph. In the adjacent field east of Home #2, a 640 type pump jack was blown over. While not a formal damage indicator, similar type occurrences in past history would suggest that winds associated with EF3 tornadoes could cause pump jacks of this size to topple. The assessment team also looked at tree damage at Home #2. Both softwood and hardwood trees were viewed on the property. Damage to these large trees was indicative of high end EF2 to low end EF3 damage.

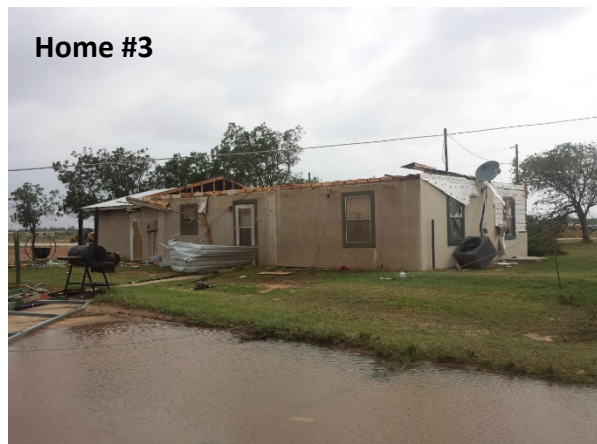
Home #3 experienced tornado damage indicative of EF2 damage. In the examples shown, large sections of the roof were removed, but with the walls still standing. At Home #3, there were power poles that were snapped approximately 5 feet off the ground. Wind speeds at this residence are estimated at 115 to 125 mph. At Home #1, trees were uprooted. Also, removal of the roof likely was aided by wind impacting an attached overhang on the

home. Wind speeds are estimated at this location of 105 to 115 mph.

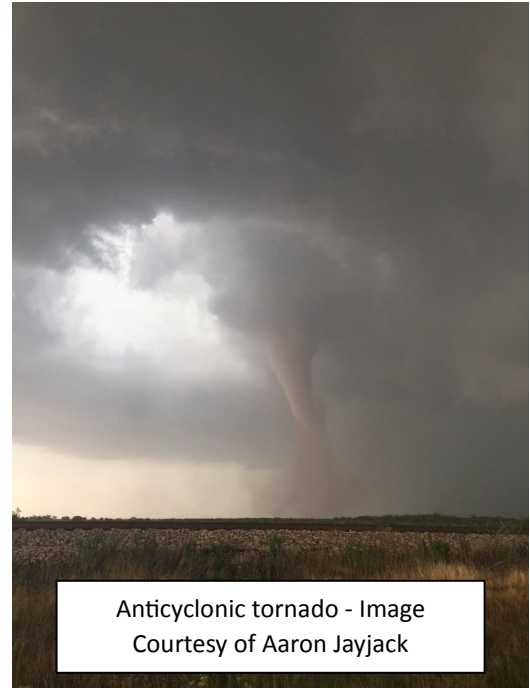
In total, eight tornadoes occurred on Sunday evening across Howard and Glasscock counties. One of the more viewed tornadoes during the event (referenced as "Tornado #2") was an anticyclonic tornado that was visible from Interstate-20. Tornado #2 developed at around 6:51 pm CDT, approximately 3 miles south of the interstate, close to Farm-to-Market Road 818. This tornado moved slowly east and then northeast. With the help of radar imagery, it is estimated that the tornado lasted 8 minutes, while travelling a path just short of 2 miles. With the tornado remaining over open fields, the assessment team rated the tornado as an EF0. The width was estimated at 100 yards.

Anticyclonic tornado - Image
Courtesy of Aaron Jayjack

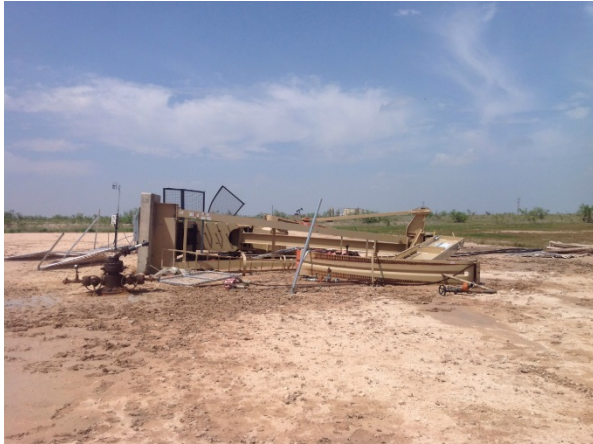
As the supercell thunderstorm moved southward along Ranch Road 33, tornado #5 developed at 755 pm CDT, approximately 4 miles southwest of Lees, north of Hillger Road. The tornado, estimated at 200 yards wide, snapped 14 power poles along Hillger Road as it moved slowly southeast. With the poles being snapped approximately 5 feet off the ground, wind speeds were estimated at approximately 115 mph, indicating a lower-end EF2 tornado intensity. There was also a nearby metal building just south of Hillger Road which sustained a loss of metal roof panels due to the tornado. Wind speeds at this location were estimated at 90-100 mph, indicating EF1 intensity. As it weakened in intensity, this slow moving tornado made an abrupt turn to the northeast and dissipated at 8:07 pm CDT near the intersection of Hillger Road and Ranch Road 33.

west of Ranch Road 33. This damage indicator suggested the tornado had weakened to EF1 intensity at that point. This weakening trend coincided with the tornado taking a more southeast track as it crossed Ranch Road 33. The tornado dissipated at 8:54 PM CDT, 2 miles north of Garden City. In total, the tornado traveled a 3.7 mile path, with an estimated width of 200 yards.

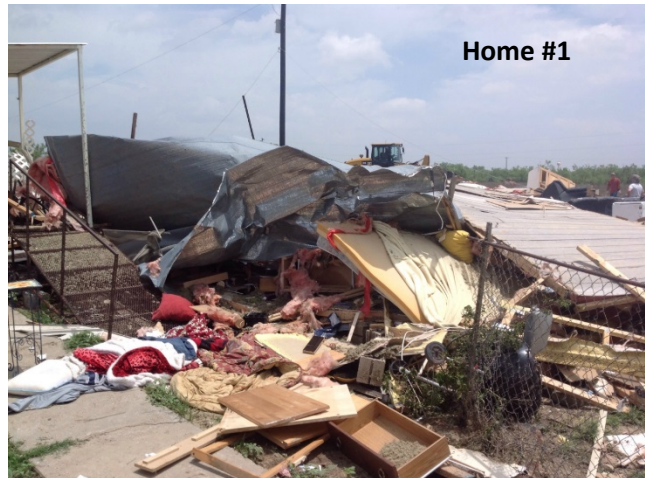
Tornado #7 developed around at 8:56 PM CDT, just over 1 ½ miles NNW of Garden City. This tornado produced a combination of EF1 and EF2 damage at two residences. A single-wide manufactured home at Home #1 was rolled and destroyed. This was indicative of damage produced by a tornado of EF2 intensity. As the tornado moved southwestward and impacted Home #2, a combination of EF1 and EF2 damage was noted. Tree damage was indicative of EF1, while the metal barn appears to

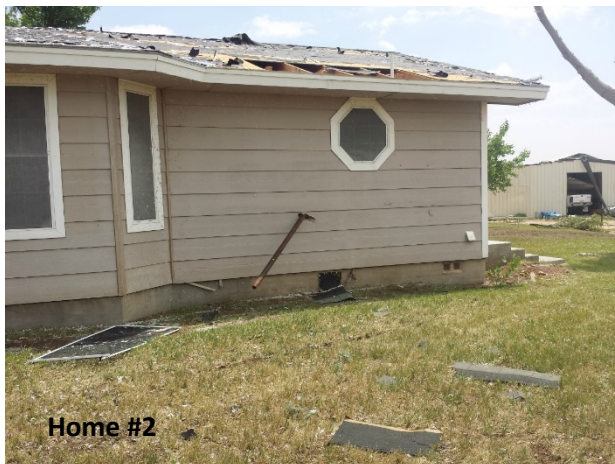
Home #2

have sustained lower-end EF2 damage. It is noted however that the barn construction made it more susceptible to wind entering the structure, which could have resulted in damage at a lower wind threshold. Wind speeds are estimated at 100-115 mph with this damage.

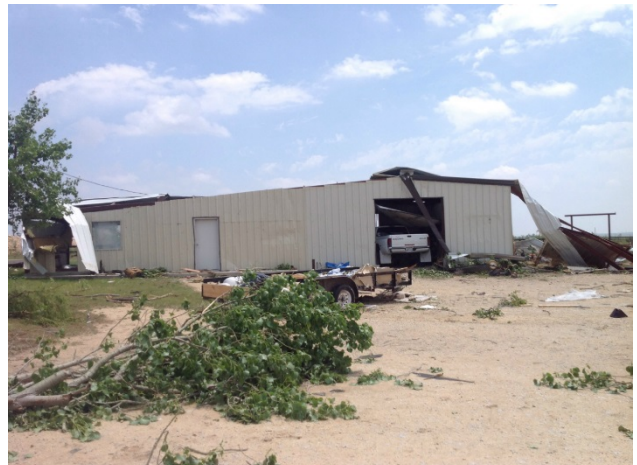
As the tornado moved southwestward, it was the opinion of the assessment team that the tornado intensified. At approximately 9:01 PM CDT, the tornado knocked over a 320 type pump jack west of

County Road 417. With this slightly smaller pump jack type, it was felt that winds in the 120-135 mph range could potentially produce this damage. Thus, we rated the tornado as being of high-end EF2 intensity. Oil field workers noted that there was damage over open fields farther to the southwest. Using radar estimates, the team concluded that this tornado dissipated at 9:02 pm CDT just short of reaching Highway 158, 1 ½ miles west of Garden City. The total path length for tornado #7 was 1.9 miles with its greatest width estimated at 150 yards.
